**Quarterly Monitoring Report
Ground Water and Marine Water Analysis**

NAVI MUMBAI INTERNATIONAL AIRPORT (NMIA)

Period:

July - September 2018

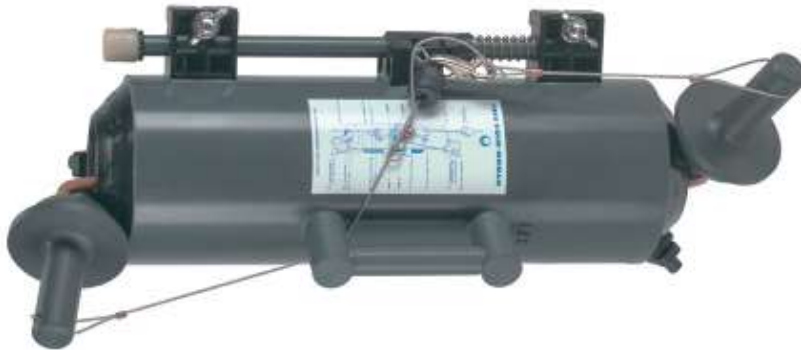
3.2.2.1 Niskin Bottle - Marine Water Sampler

This Water Sampler is used to collect samples at various water depths and can operate at any depth on a cable or line with a messenger.

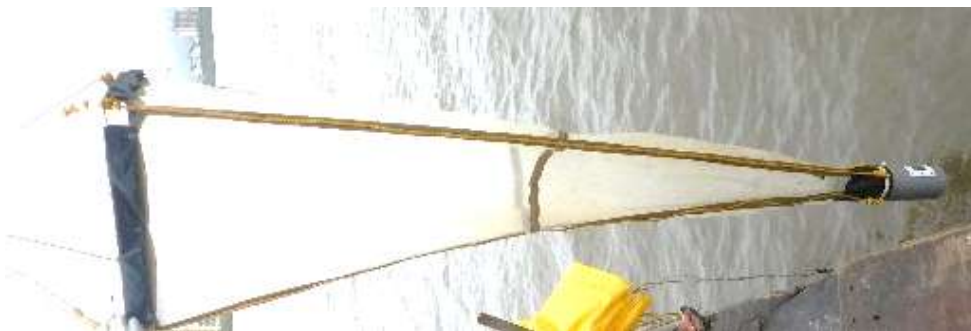
3.2.2.2 Plankton Net - Biological Samples

This plankton net operates a cable or lined by hand or behind a boat, it can be towed vertically or horizontally. Nets comes in varieties of size (Mesh no 00 equal an aperture of 0.30 inches)

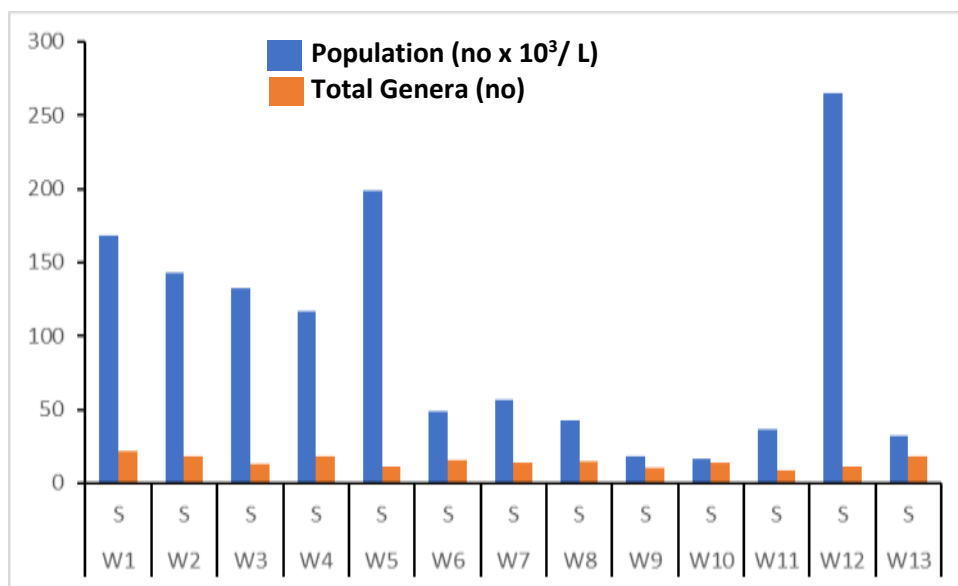
Figure 4.1 : Representation of phytoplankton population & Total genera for July 2018

In July 2018, Phytoplankton population density ranges from 16.4-256.2 x 10³/l at surface water of all 13 stations. Highest phytoplankton population at surface water of station 12 may be due to influx of domestic water from surrounding villages; total generic groups ranges from 9-18 nos. at surface water of 13 stations. Maximum generic diversity 18 no. is observed at surface water of Station 4 during July 2018.

The graph below represents the population of phytoplankton is more at station 12; and less at station 10, which represents there is discharge of sewage and domestic waste. The phytoplankton trend with respect to total number of genera is almost same throughout all stations. Some of the major genera seen were photographed and shown in **figure 4.2**.

The other fresh water phytoplankton genera found are *Scenedesmus*, *Oscillatoria* in Gadhi River (Station 2). *Nitzschia*, *Thalassiosira* and *Navicula* are common Genera noted in all stations. Graphical representations of phytoplankton population and total genera is represented in **Figure 4.1**.

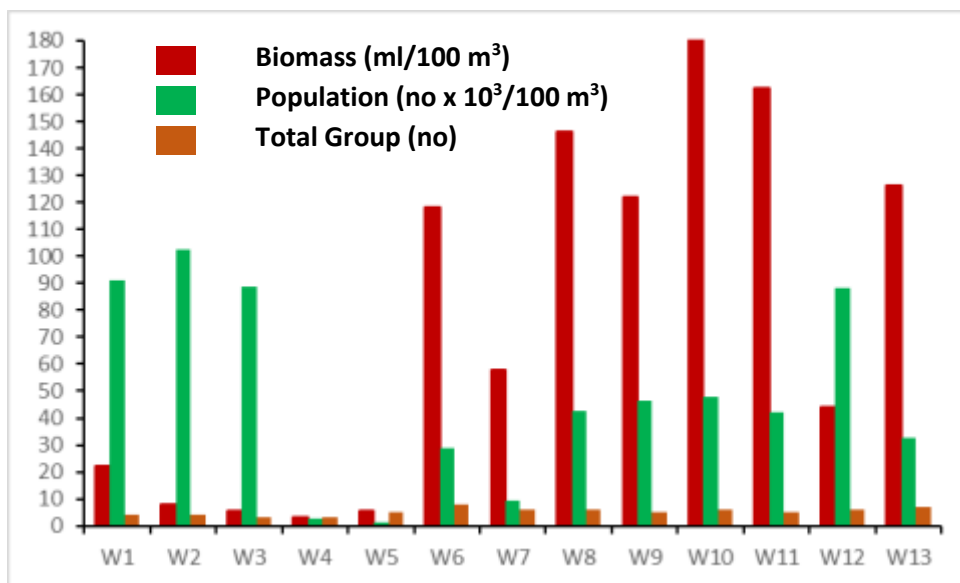
Figure 4.3: Graphical representations of Zooplankton Biomass, Population and total group for July 2018

In July 2018, the zooplankton biomass ranged from 3.12 to 182.59 ml/100 m³ with population density of 1.36 to 102.32 no x 10³/100m³ while having good faunal group ranging from 3-8 nos. The zooplankton was noted with good population and group diversity. Copepods, Gastropods & polychaetes were common groups observed as, figures 4.3 represents zooplankton standing stock graphically.

The graph below represents that average standing stock reported from all stations; Station 5 shows lowest population as compared to Station 2; and station 4 shows lowest biomass and Station 10 shows highest biomass respectively.
