**Quarterly Monitoring Report  
Ground Water and Marine Water Analysis**

**For  
NAVI MUMBAI INTERNATIONAL AIRPORT (NMIA)**

**January - March 2019**

**ADITYA ENVIRONMENTAL SERVICES PVT.LTD.  
MOEFCC Recognized Laboratory under EP Act 1986  
Accredited under ISO 9001: 2008 & OHSAS 18001: 2007 by ICQS  
[www.aespl.co.in](http://www.aespl.co.in)**

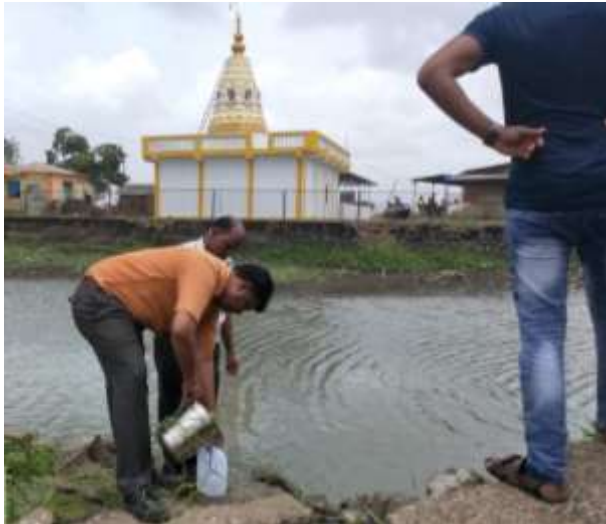
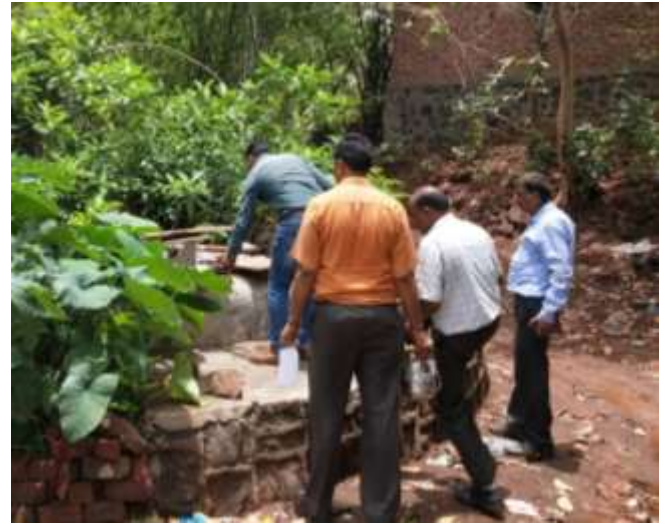
Ground water sample is collected by using containers and the sampling container is rinsed before using it for storing water samples. Ground water samples are stored in two separate containers for Physicochemical & Microbiological analysis and preservatives added as recommended by Standard Methods APHA, stored in cold storage box and transferred to the laboratory for the further analysis.

**Ground Water Sampling in Progress**

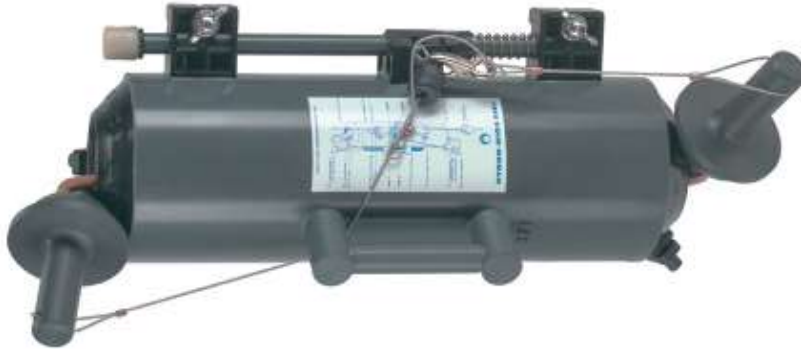
#### 3.2.2.1 Niskin Bottle - Marine Water Sampler

This Water Sampler is used to collect samples at various water depths and can operate at any depth on a cable or line with a messenger.

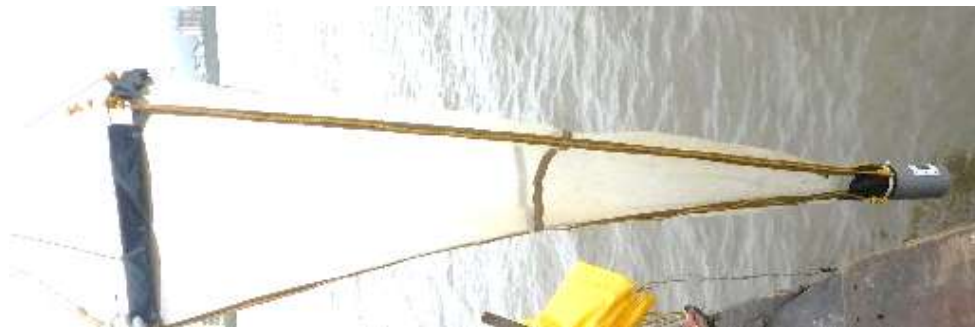
#### 3.2.2.2 Plankton Net - Biological Samples

This plankton net operates a cable or lined by hand or behind a boat, it can be towed vertically or horizontally. Nets comes in varieties of size (Mesh no 00 equal an aperture of 0.30 inches)

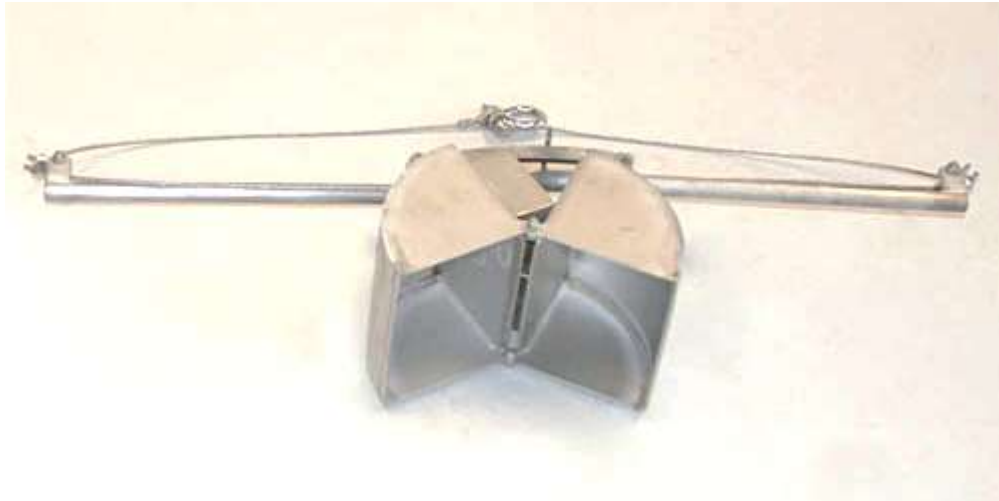
**Grab Sampler**

Sediment grab operate at any depth on a cable or line by free fall (without a messenger). It is extremely heavy and can take samples of hardest rocky ocean bottoms.

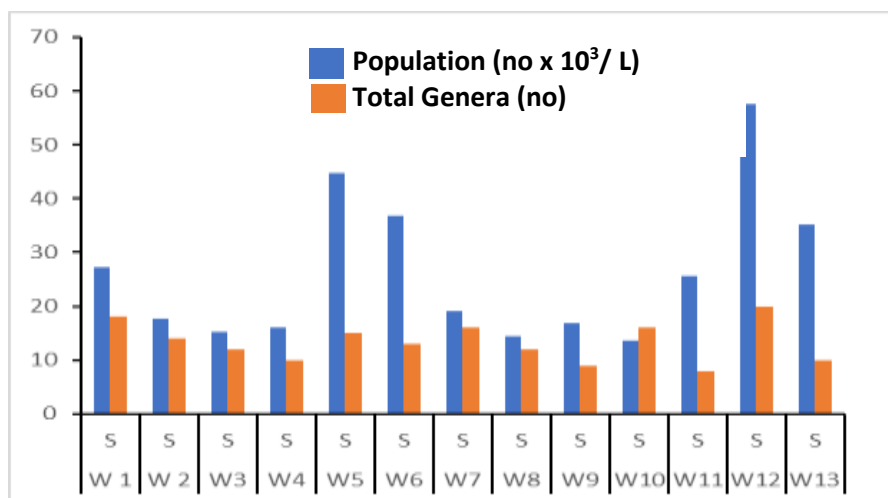
Figure 4.1 : Representation of phytoplankton population & Total genera for March 19

In March 2019, Phytoplankton population density ranges from 13.6-57.6 x 10<sup>3</sup>/l at surface water of all 13 stations. Highest phytoplankton population at surface water of station 12 may be due to influx of domestic water from surrounding villages; total generic groups ranges from 8-20 nos at surface water of all 13 stations. Maximum generic diversity 20 no. is observed at surface water of Station W12 during March 2019.

*Thalassiosira, Navicula, Pleurosigma and Cyclotella* are most common ones, followed by rest of observed genera like *Coscinodiscus, Scenedesmus, Nitzscha*. The other freshwater phytoplankton genera found are *Scenedesmus, Oscillatoria and Pediastrum* in Gadhi River (Station 1) and Ulwe River (Station 12) respectively. *Nitzschia, Thalassiosira* and *Navicula* are common Genera noted in all stations. Graphical representations of phytoplankton population and total genera is represented in **Figure 4.1**.

The graph below represents the population of phytoplankton is more at station 12; and less at station 10, which represents there is discharge of sewage and domestic waste. The phytoplankton trend with respect to total number of genera is almost same throughout all stations. Some of the major genera seen were photographed and shown in **Figure 4.2**.

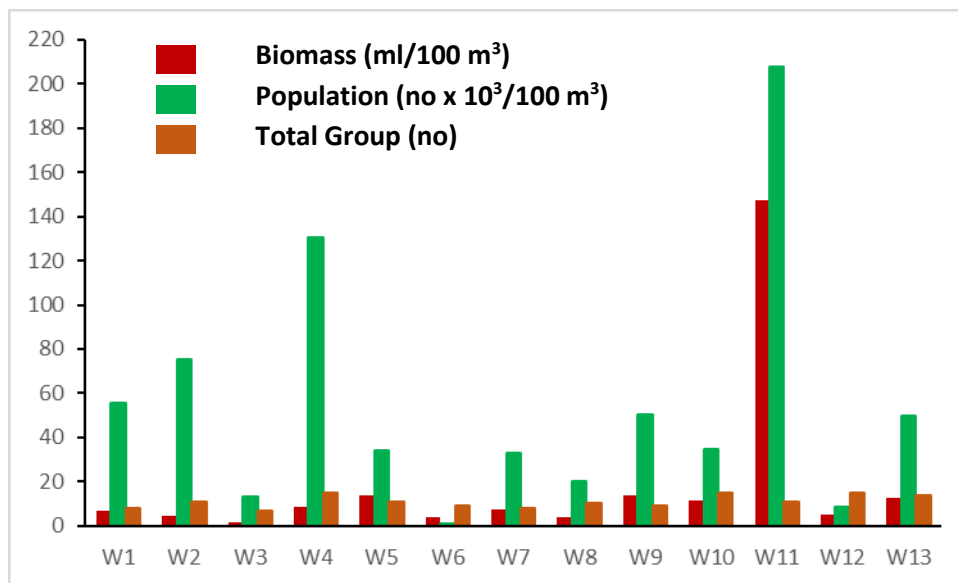
Figure 4.3: Representations of Zooplankton Biomass, Population & Total group for March 19

In March 2019, the zooplankton biomass ranged from 1.8 to 147.6 ml/100 m<sup>3</sup> with population density of 1.2 to 207.5 no x 10<sup>3</sup>/100m<sup>3</sup> while having good faunal group ranging from 7-15 nos. The zooplankton was noted with good population and group diversity. Copepods, Gastropods & decapods were common groups observed as, **Figure 4.3** represents zooplankton standing stock graphically.

The graph below represents that average standing stock reported from all stations; Station 6 shows lowest population as compared to Station 11 with highest population; and station 3 shows lowest biomass and Station 11 shows highest biomass respectively.
