ENVIRONMENTAL COMPLIANCE MONITORING REPORT
for
Navi Mumbai International Airport (NMIA)

City and Industrial Development Corporation of Maharashtra Ltd (CIDCO)

July to December 2017

ADITYA ENVIRONMENTAL SERVICES PVT.LTD.
MOEFCC Recognized Laboratory under EP Act 1986
Accredited under ISO 9001: 2008 & OHSAS 18001: 2007 by ICQS
QCI NABET Accredited EIA Consultancy Organization
www.aespl.co.in

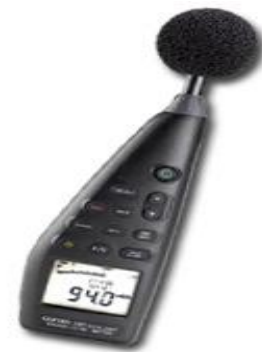
Integrated Sound Level Meter C390 was used for undertaking the surveys and installed on tripods at the selected locations over a 24-hour period. This Meter is then taken to laboratory where the data collected is downloaded onto PC using specialized software.

**Center C-390 Sound level
Meter with data logger**

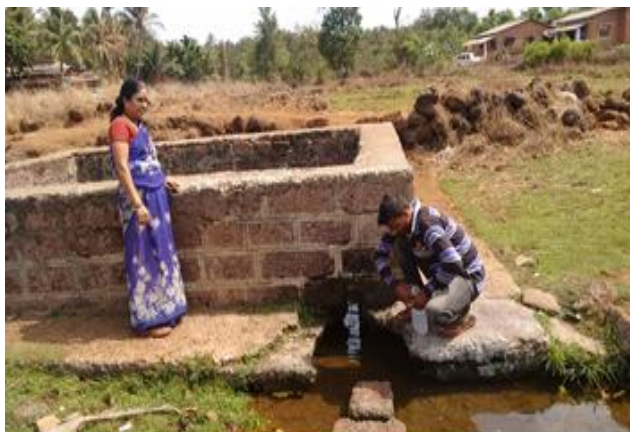
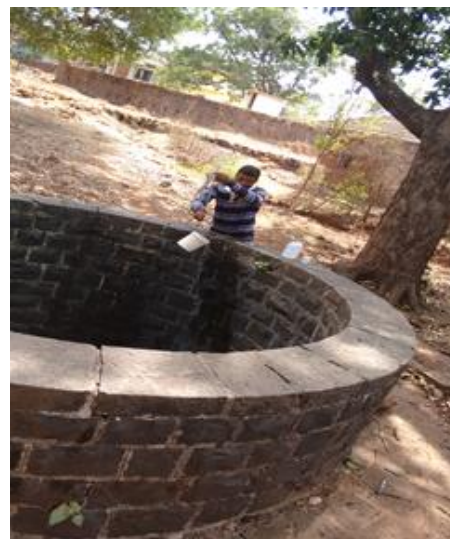
Ground Water Sampling in Progress

Ground water sample is collected by using containers and the sampling container is rinsed before using it for storing water samples. Ground water samples are stored in two separate containers for Physicochemical & Microbiological analysis and preservatives added as recommended by Standard Methods APHA, stored in cold storage box and transferred to the laboratory for the further analysis.

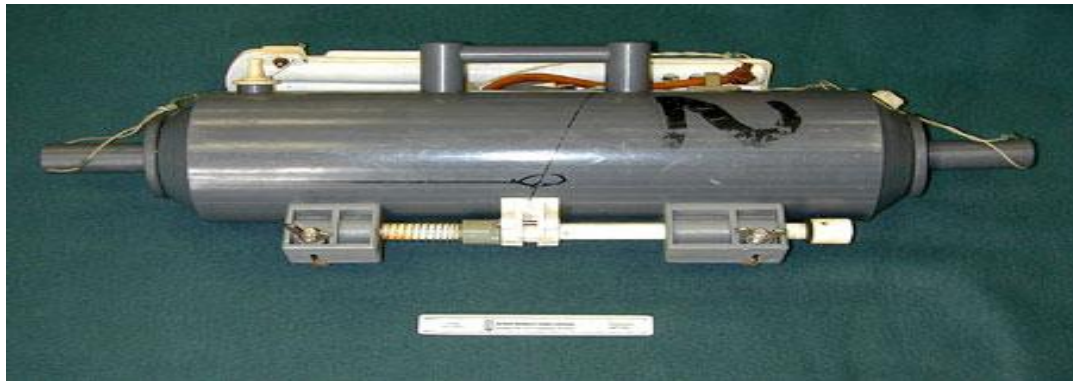
3.5.2.1 Niskin Bottle - Marine Water Sampler

This Water Sampler is used to collect samples at various water depths and can operate at any depth on a cable or line with a messenger.

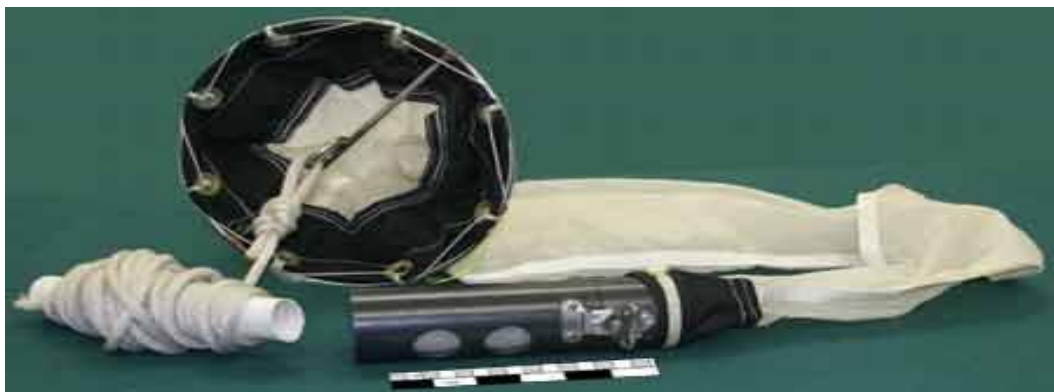
3.5.2.2 Plankton Net - Biological Samples

This plankton net operates a cable or lined by hand or behind a boat, it can be towed vertically or horizontally. Nets comes in varieties of size (Mesh no 00 equal an aperture of 0.30 inches)

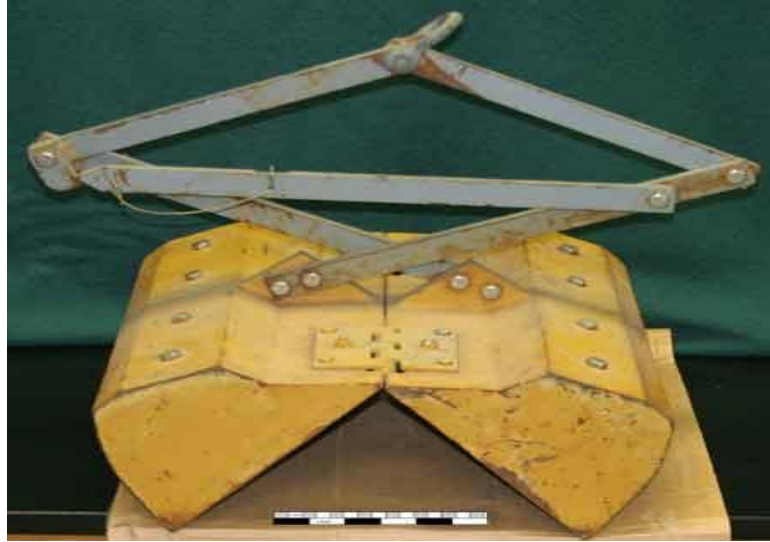
Grab Sampler

Sediment grab operate at any depth on a cable or line by free fall (without a messenger). It is extremely heavy and can take samples of hardest rocky ocean bottoms.

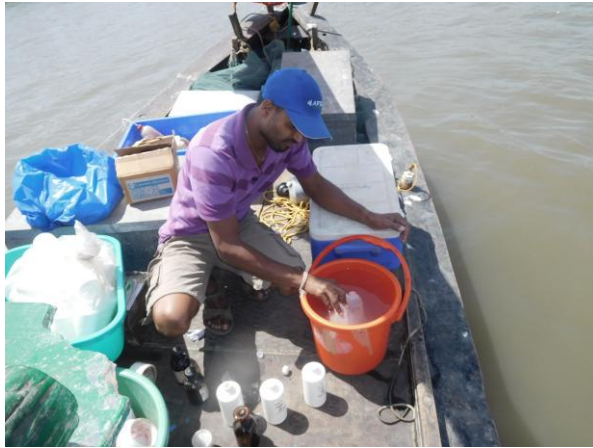
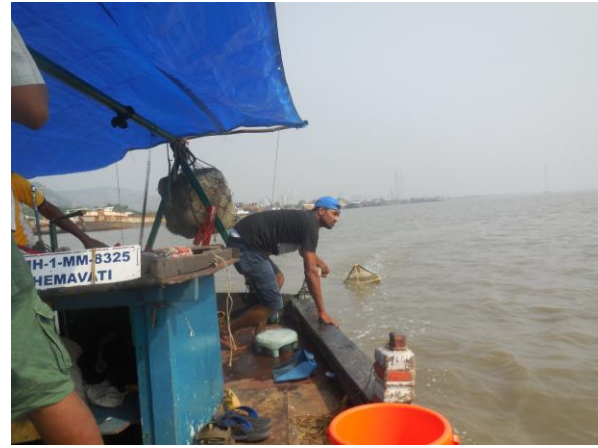
Marine water sampling in progress

Marine samples were collected from sampling locations in Gadhi River, Ulwe River and Panvel Creek at the locations indicated by CIDCO – in all 26 samples were collected from 13 sampling locations for physicochemical samples (Stations 1 to 10 are located in Gadhi River & Station 11 & 13 are in Panvel Creek while station 12 in Ulwe River), while 3 samples were collected 1 from Ulwe river and 2 at entrance of Gadhi rivers for biological samples. A good amount of mangrove vegetation was noted on either side of stream from station 4 to 6. Sampling locations were approached by boat (wherever possible) and collection done irrespective of tide. Depending of water depth at sampling location during sampling, both (surface and bottom) samples were collected. The samples were preserved and taken to laboratory using vehicle on same day.

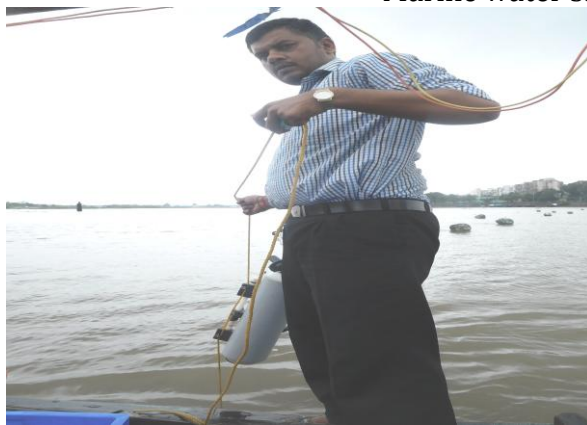
Bottom marine water sampling

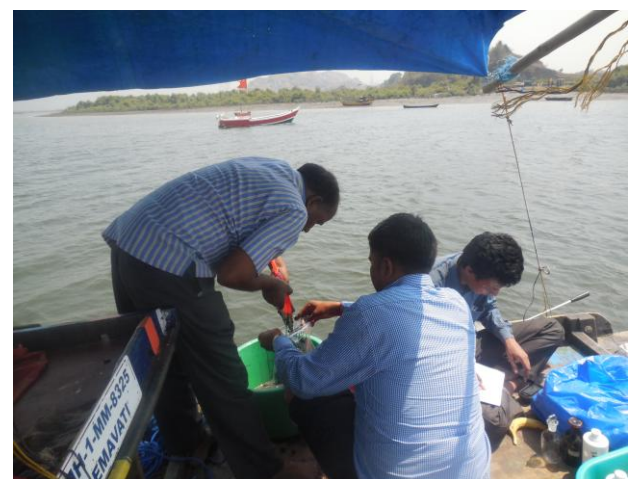
Collection of benthos sample

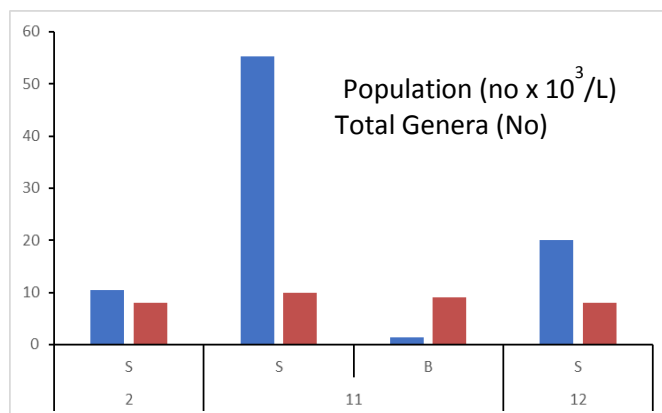
Figure 4.2 : Graphical representation of phytoplankton population and total genera for July 2017

The above graph represents the population of phytoplankton is more at

station 11 and 12; and less at station 2 at Gadhi River, which represents there is discharge of sewage and domestic waste. The phytoplankton trend with respect to total number of genera is almost same throughout all stations. Some of the major genera seen were photographed and shown in figure 4.1.

The other fresh water phytoplankton genera found are *Scenedesmus*, *Oscillatoria*, *Closterium* and *Staurostrum* in Gadhi River (Station 2). *Nitzschia*, *Thalassiosira* and *Navicula* are common Genera noted in all stations 2, 11 and 12 mostly present in surface water. Graphical representations of phytoplankton population and total genera is represented in Figure 4.2.

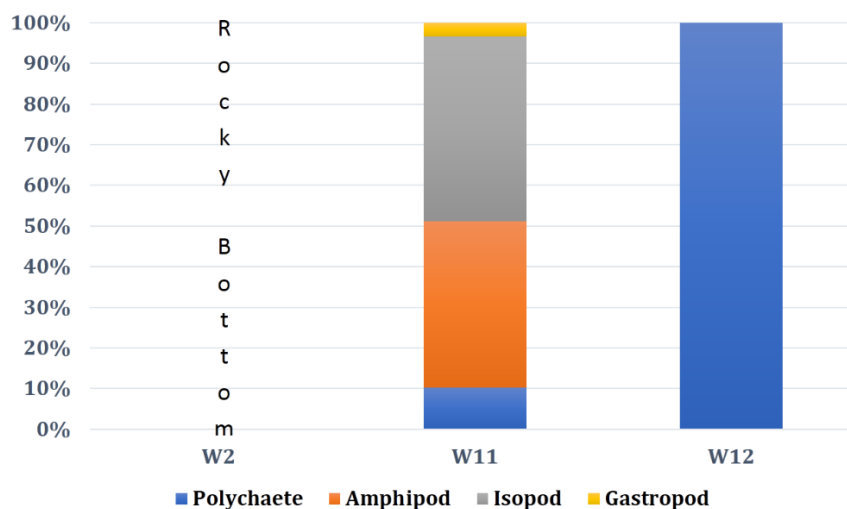
Figure 4.5: Graphical representation of benthic population for July 2017

The benthic organisms found at sampling area shown in Figure 4.6 and Figure 4.5 represents the graphical representations of population of benthic organisms' groups in percentage.

The graphs represent the Polychaete as major stable benthic component.

Macro-benthic biomass noted 8.49 to 33.3 gm/m² with population 8.33 to 36.66 x 10²/m² and Polychaete being only faunal group found at station 11 and 12 respectively. Benthic sample couldn't be collected at station 2 because of hard bottom. The benthos observed was poor in terms of biomass of Benthos, population & diversity as well.
